# Inspection Readiness Report

RightShip Inspection Ship Questionnaire (RISQ 3.2)

Report date 30 Sep 2026 · Ref. CR-RIGHTSHIPPRO-20260930-6E11

## MV Demo Star

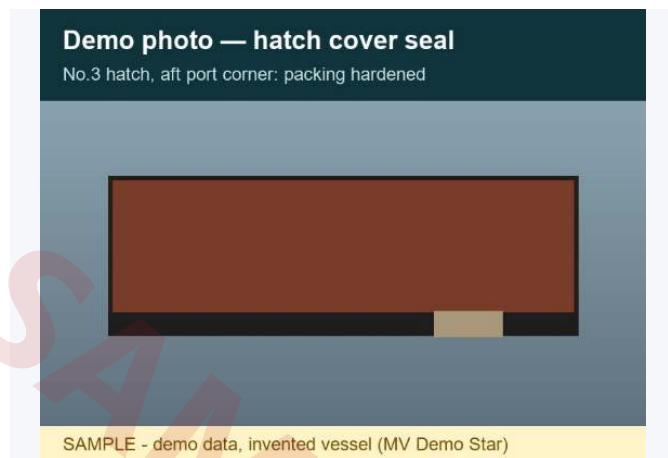
| # | Ref / location | Observation | Corrective action / remark | Owner | Due | Severity / status |
|---|---|---|---|---|---|---|
| 1 | 9A / 9.9<br>Hatch Cover and Lifting Appliances | No.3 hatch cover: rubber packing hardened and a 40 cm section missing at the aft port corner; last ultrasonic tightness test not recorded. Photos: P1 | Renew packing on No.3 hatch (spares on board), carry out and record an ultrasonic tightness test on all hatches before arrival. | Chief Officer | 10 Oct 2026 | High Finding - open raised 21 Sep 2026 |

| Q no. | Question | Status | Notes / findings / evidence |
|---|---|---|---|
| 9.9 | Question 9.9 | Finding | Finding: No.3 hatch cover: rubber packing hardened and a 40 cm section missing at the aft port corner; last ultrasonic tightness test not recorded.<br>Photos: P1 |

**P1** RISQ 9A / 9.9 - Demo photo - No.3 hatch cover rubber packing, aft port corner (25 Sep 2026)

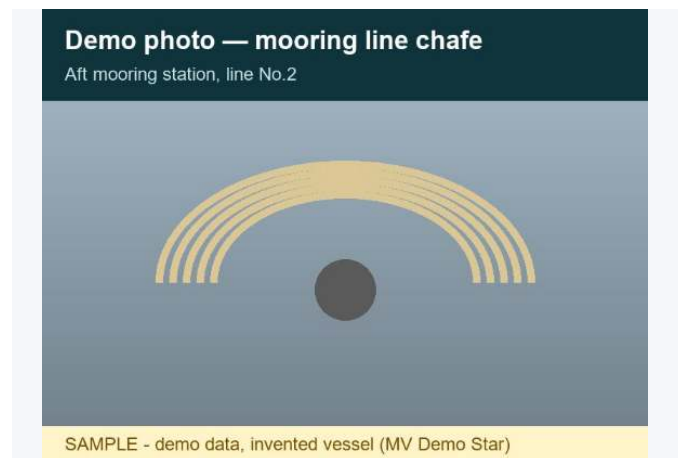
| # | Ref / location | Observation | Corrective action / remark | Owner | Due | Severity / status |
|---|---|---|---|---|---|---|
| 3 | 10 / 10.4<br>Mooring Operations | Aft mooring line No.2 shows chafe over about 1 m near the eye; not entered in the mooring line inspection record. Photos: P2 | Replace or end-for-end the line, update the mooring line management plan and inspection log. | Ratings | 25 Sep 2026<br>OVERDUE | Medium Finding - overdue raised 22 Sep 2026 |

| Q no. | Question | Status | Notes / findings / evidence |
|---|---|---|---|
| 10.4 | Question 10.4 (M) | Finding | Finding: Aft mooring line No.2 shows chafe over about 1 m near the eye; not entered in the mooring line inspection record. Photos: P2 |

**P2** RISQ 10 / 10.4 - Demo photo - chafe on aft mooring line No.2 (26 Sep 2026)

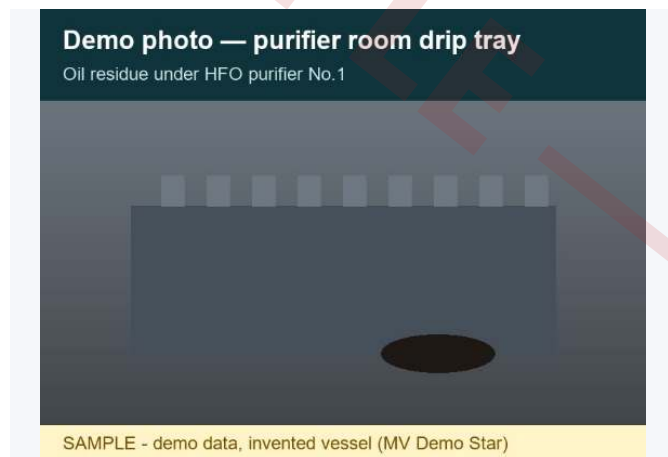
| # | Ref / location | Observation | Corrective action / remark | Owner | Due | Severity / status |
|---|---|---|---|---|---|---|
| 4 | 13 / 13.29<br>Machinery Space | Oil residue in the drip tray under HFO purifier No.1; tray drain partly blocked. Photos: P3 | Clean tray, clear drain, trace and fix the small leak at the purifier inlet flange. | C/E & 2/E (Engineers) | 12 Oct 2026 | Medium Observation - open raised 23 Sep 2026 |

| Q no. | Question | Status | Notes / findings / evidence |
|---|---|---|---|
| 13.29 | Question 13.29 | Observation | Observation: Oil residue in the drip tray under |

| Q no. | Question | Status | Notes / findings / evidence |
|---|---|---|---|
| | | | HFO purifier No.1; tray drain partly blocked.<br>Photos: P3 |

**P3** RISQ 13 / 13.29 - Demo photo - oil residue in purifier drip tray (27 Sep 2026)

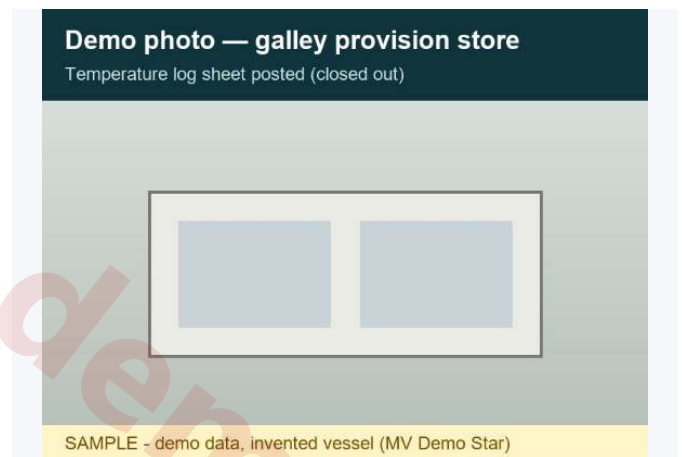
| # | Ref / location | Observation | Corrective action / remark | Owner | Due | Severity / status |
|---|---|---|---|---|---|---|
| 6 | 15 / 15.5<br>Health and Welfare of Seafarers | Provision store temperature log not posted at the store entrance. Photos: P4 | Log sheet posted and daily readings started (closed out). | Master | 28 Sep 2026 | Closed Observation - closed 27 Sep 2026 raised 26 Sep 2026 |

**P4** RISQ 15 / 15.5 - Demo photo - provision store temperature log, now posted (28 Sep 2026)
